## **Bridge Watchkeeping Safety Study**

**Safety Study 1/2004**  
**July 2004**

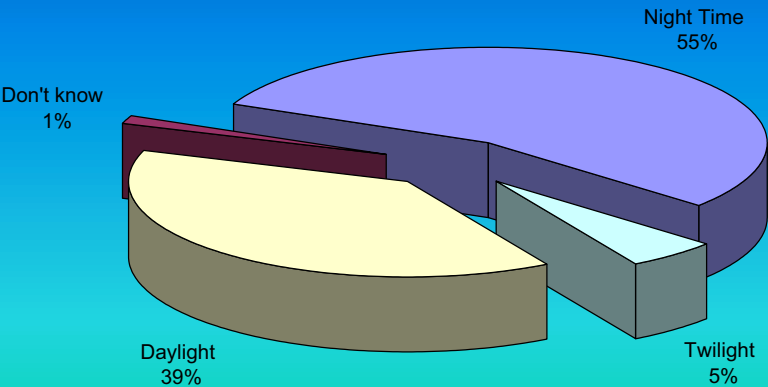
Figure 3

Vessel type

Of the 1,647 collisions, groundings, contacts and near collisions that were reported to MAIB between 1994 and 2003, 66 accidents involving 75 vessels met the required criteria. **Figures 1 to 6** show the distribution of these incidents by type, vessel type, daylight or darkness, visibility, diurnal and monthly distribution.

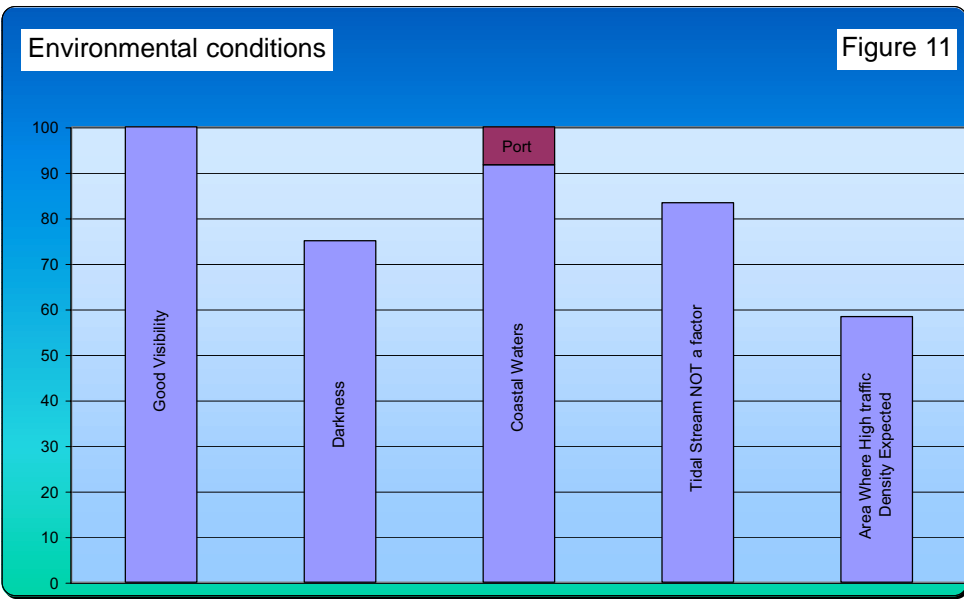
Figure 11

Environmental conditions

Twelve vessels grounded with sole watchkeepers. All were dry cargo/container vessels, 84% were less than 3,000gt (**Figure 9**); 92% carried only two deck officers, and all had three or fewer deck ratings (**Figure 10**). All of these groundings occurred in clear or good visibility, and 75% occurred during darkness. Only one occurred in a port or harbour area, the remainder occurred during coastal passage (**Figure 11**).
